Manhole Inspection Summary

Manhole # S37W1_038MH

Insp Date: **12/13/07 8:29 AM**

Location Address: **3700 S Hanover St**

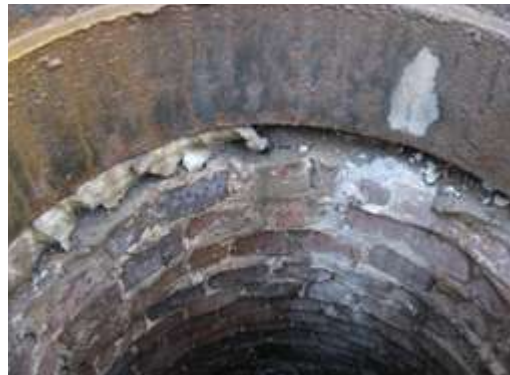
Defect 1

Condition: ☐ Sound ☒ **Cracked** ☐ Root Intrusion ☒ **Loose Brick** ☒ **Deteriorated**

Frame/Chimney Adjustment deterioration

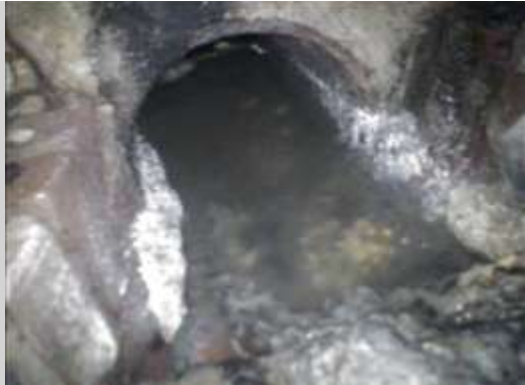
12 O'Clock Outflow

10 in. Circular Gravity Sewer
Pipe Out @ 12 O'Clock

Pipe Height: **9.6** (in.) Rod and Bar (Angled)
Pipe Material: **Clay** ☐ Pipe Lined
Invert Depth: **7.78** (ft.) Flow Characteristics: **Fast**
Deposits: ☐ None ☒ **Mud** ☒ **Sludge** ☒ **Debris** ☐ Grease
Silt Depth: **2** (in.) Deposits Extent: **Heavy**
Infiltration: **None** Pipe Seal Cond: **Sound**

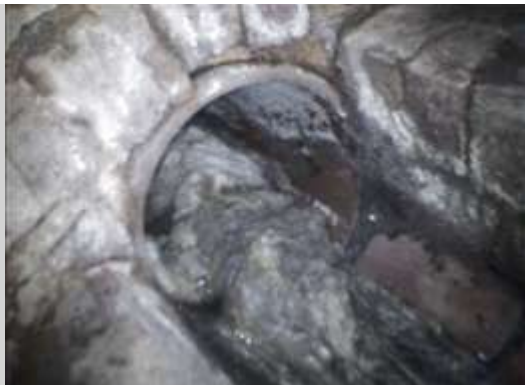
4 O'Clock Inflow

Comments **Sticks located in the 4 o'clock pipe
7 o'clock position has two adjacent pipes**

10 in. Circular Gravity Sewer
Pipe In @ 4 O'Clock

Pipe Height: **9.6** (in.) Rod and Bar (Angled)
Pipe Material: **Clay** ☐ Pipe Lined
Invert Depth: **7.22** (ft.) Flow Characteristics: **Fast**
Deposits: ☐ None ☒ **Mud** ☒ **Sludge** ☒ **Debris** ☐ Grease
Silt Depth: **3** (in.) Deposits Extent: **Heavy**
Infiltration: **None** Pipe Seal Cond: **Cracked**

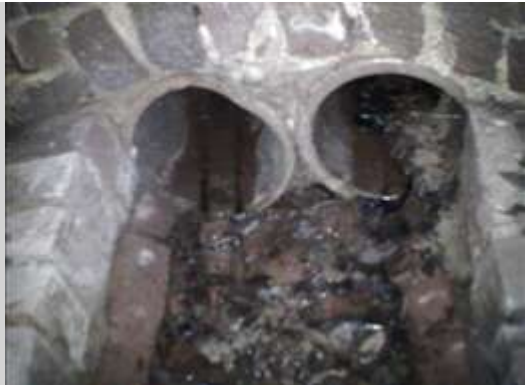
7 O'Clock Inflow

8 in. Circular Service Sewer

Deposits: ☐ None ☒ **Mud** ☒ **Sludge** ☐ Debris ☐ Grease

Silt Depth: **2** (in.) Deposits Extent: **Medium**

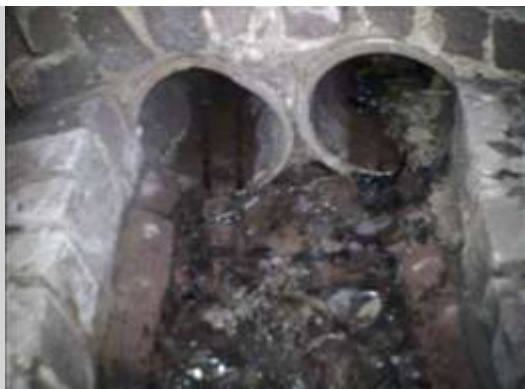
7 O'Clock Inflow

8 in. Circular Gravity Sewer

Deposits: ☐ None ☒ **Mud** ☒ **Sludge** ☐ Debris ☐ Grease

Silt Depth: **2** (in.) Deposits Extent: **Medium**
